# RAILROAD INSPECTION REPORT

RAILROAD TPWRR

LOCATION: Chenoa, IL

DOT/AAR: 802009C

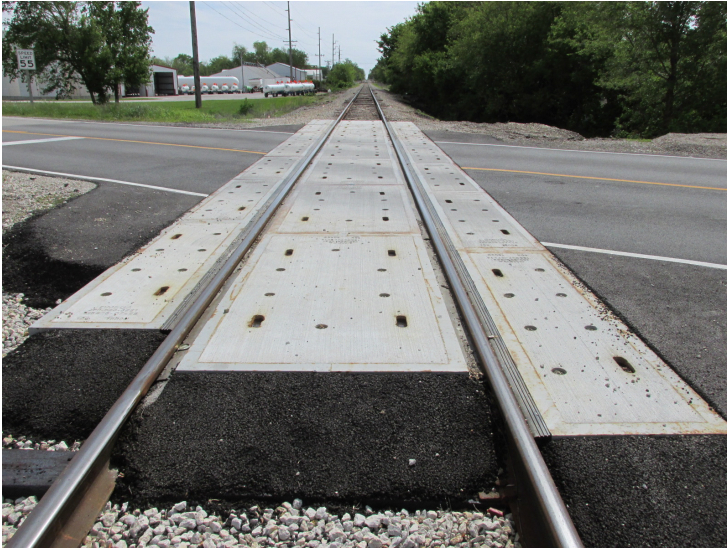
Photo Dir. East Photo Date 5/16/2016

SATISFACTORY

New concrete crossing with asphalt sub-base in 2016

Pavement on south side of crossing showing signs of severe rutting and cracking along edge of crossing surface.

Needs Normal Maintenance
